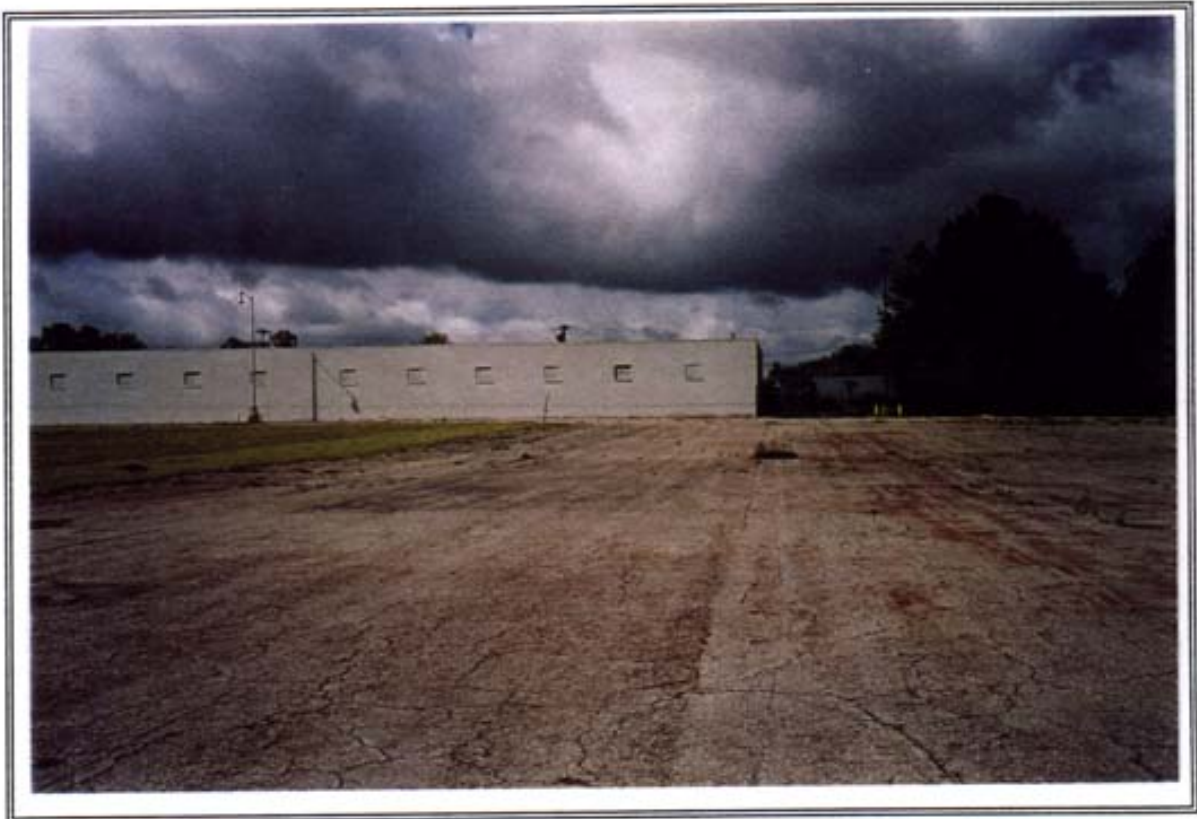
PHOTO 9. 240 VULCAN STREET: View of Study Area C (Concrete Parking Lot) and Adjacent Factory Building, Facing West.

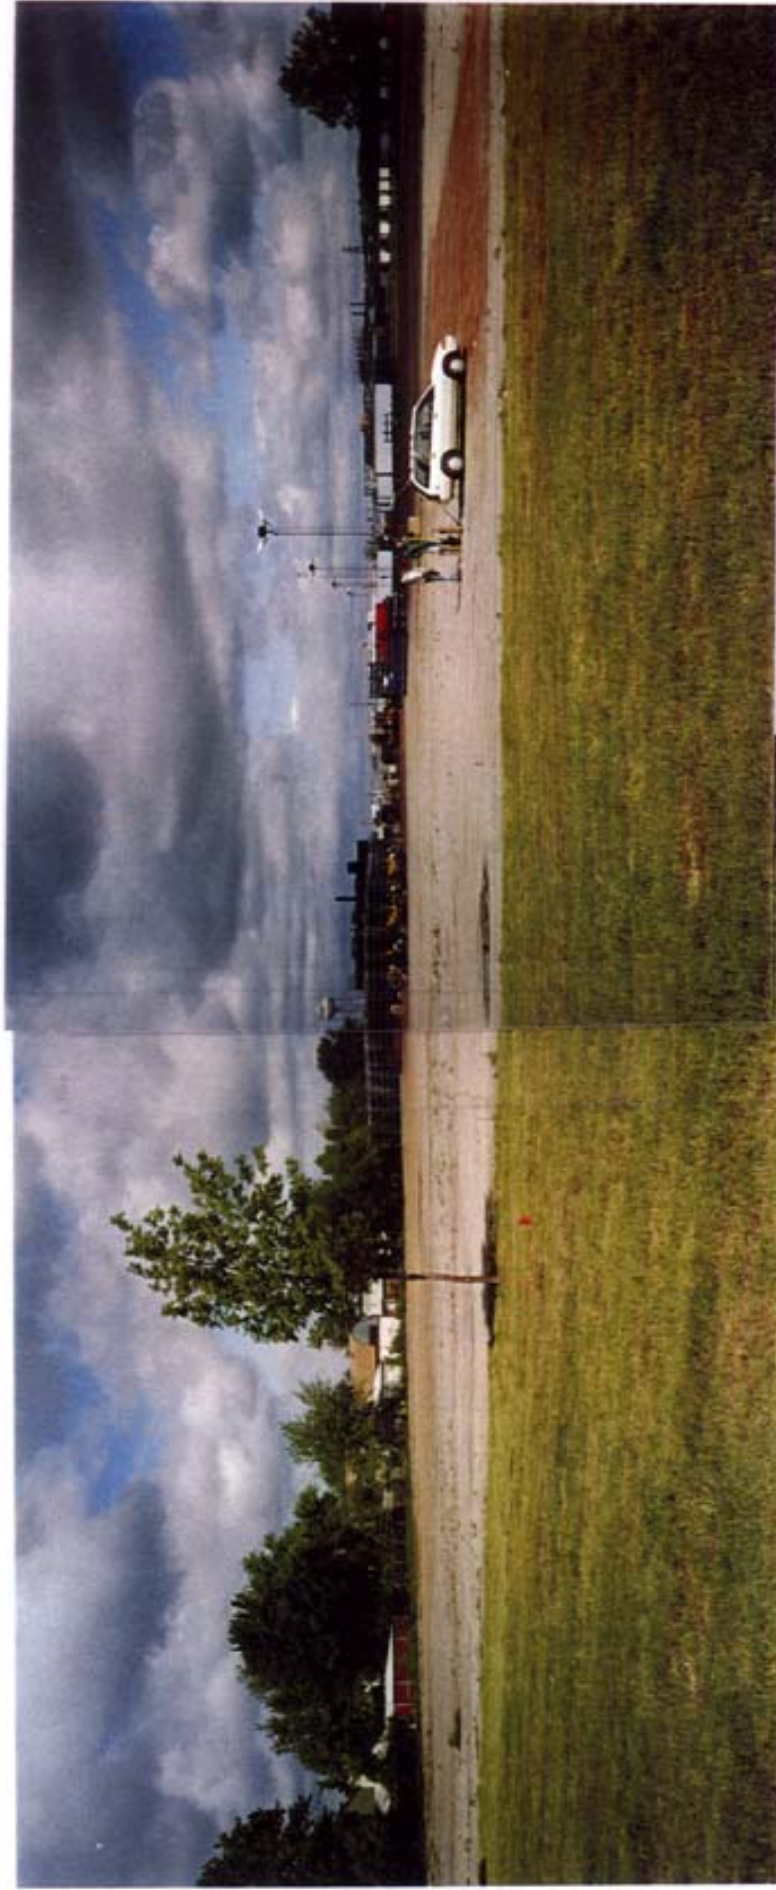
**PHOTO 10. 240 VULCAN STREET: Looking Toward Powertrain Storage Rack Area
Across Study Area C (Concrete Parking Lot), Facing North.**

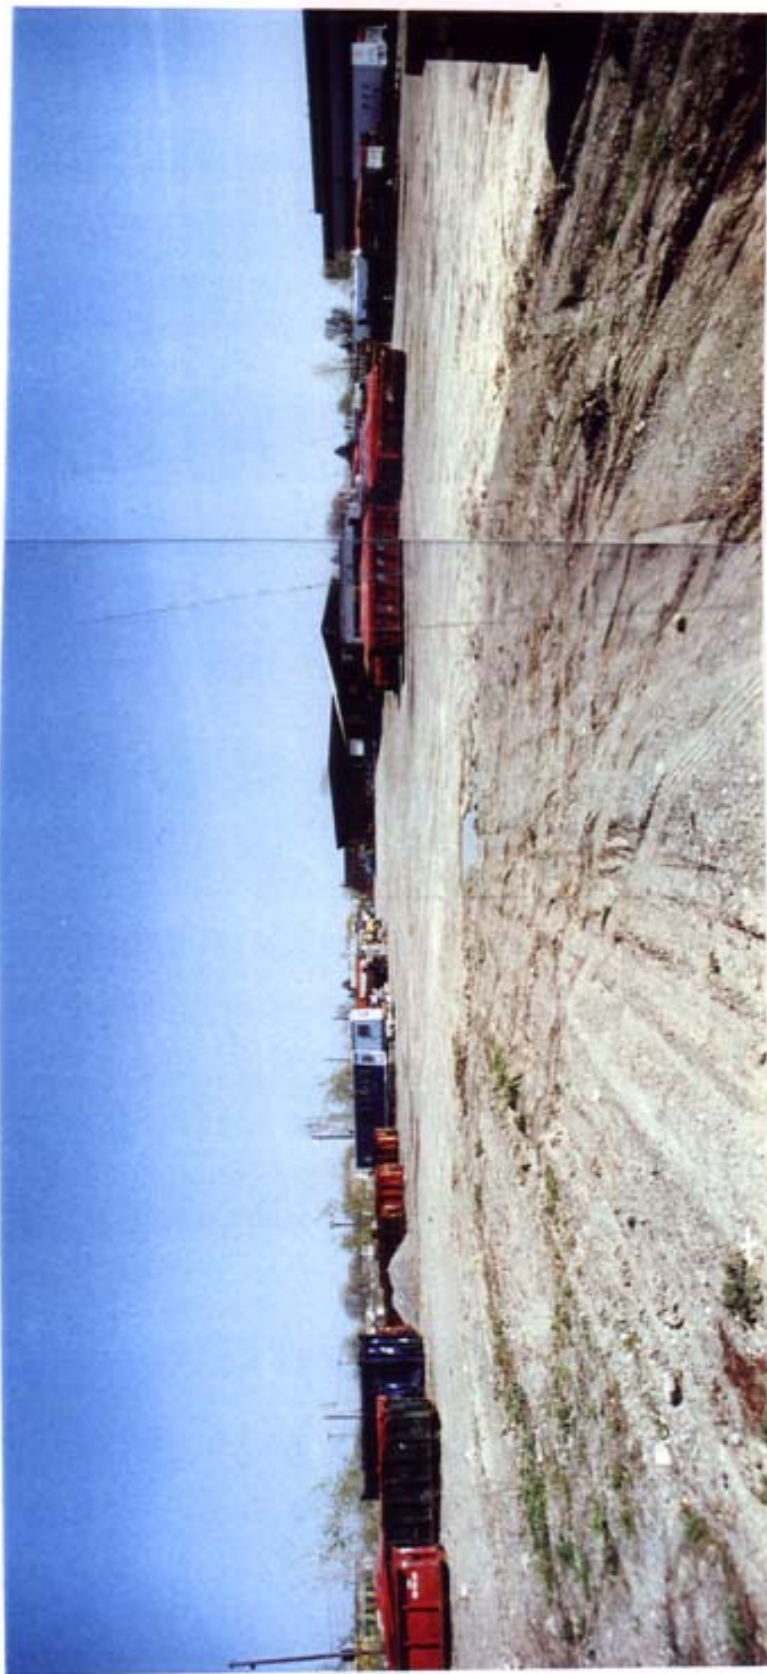
PHOTO 11. 344 VULCAN STREET: Location of Former Farrel Birmingham Building Showing Highly Disturbed Conditions, Facing South. (Note: Water-filled feature in foreground is Former Footing For Heavy Machinery.)

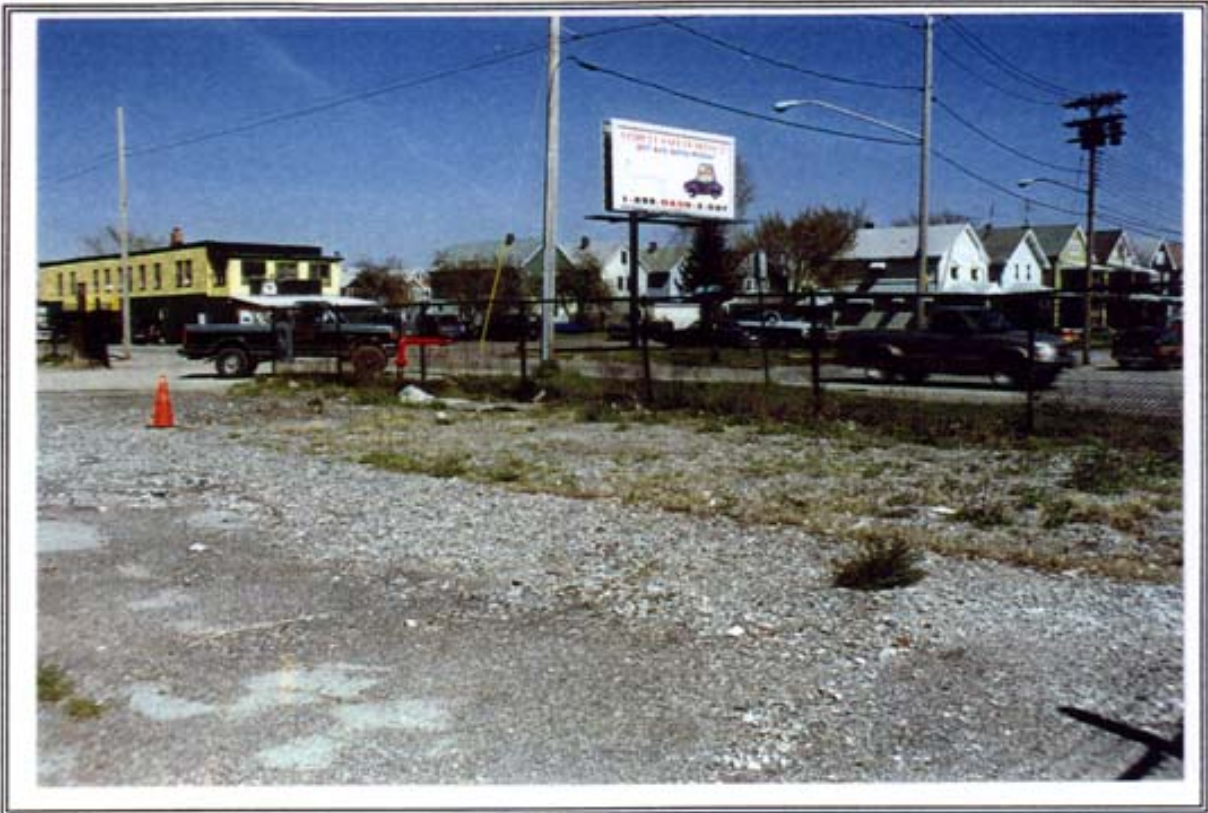
PHOTO 12. 344 VULCAN STREET: Highly Disturbed Location Along Vulcan Street, Facing Southeast.

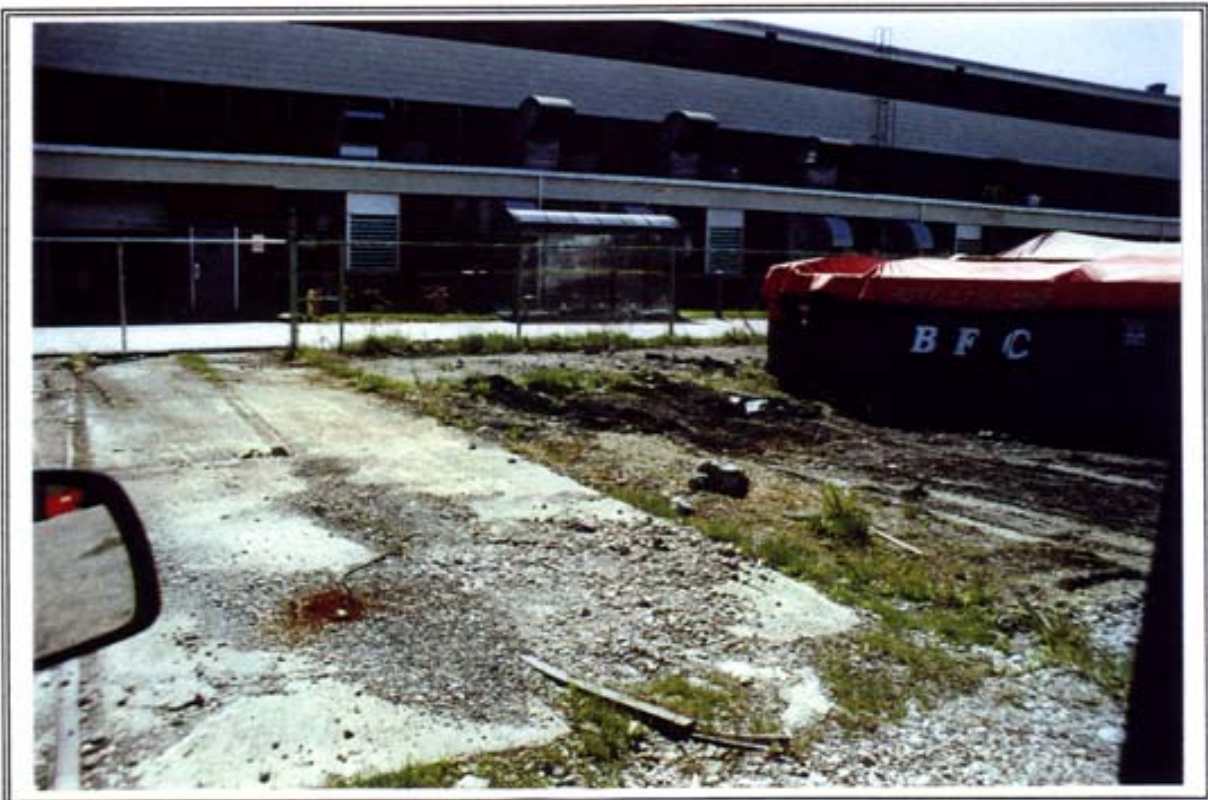
PHOTO 13. 344 VULCAN STREET: Highly Disturbed Location Along West Boundary of Farrel Birmingham Parcel, Facing West.

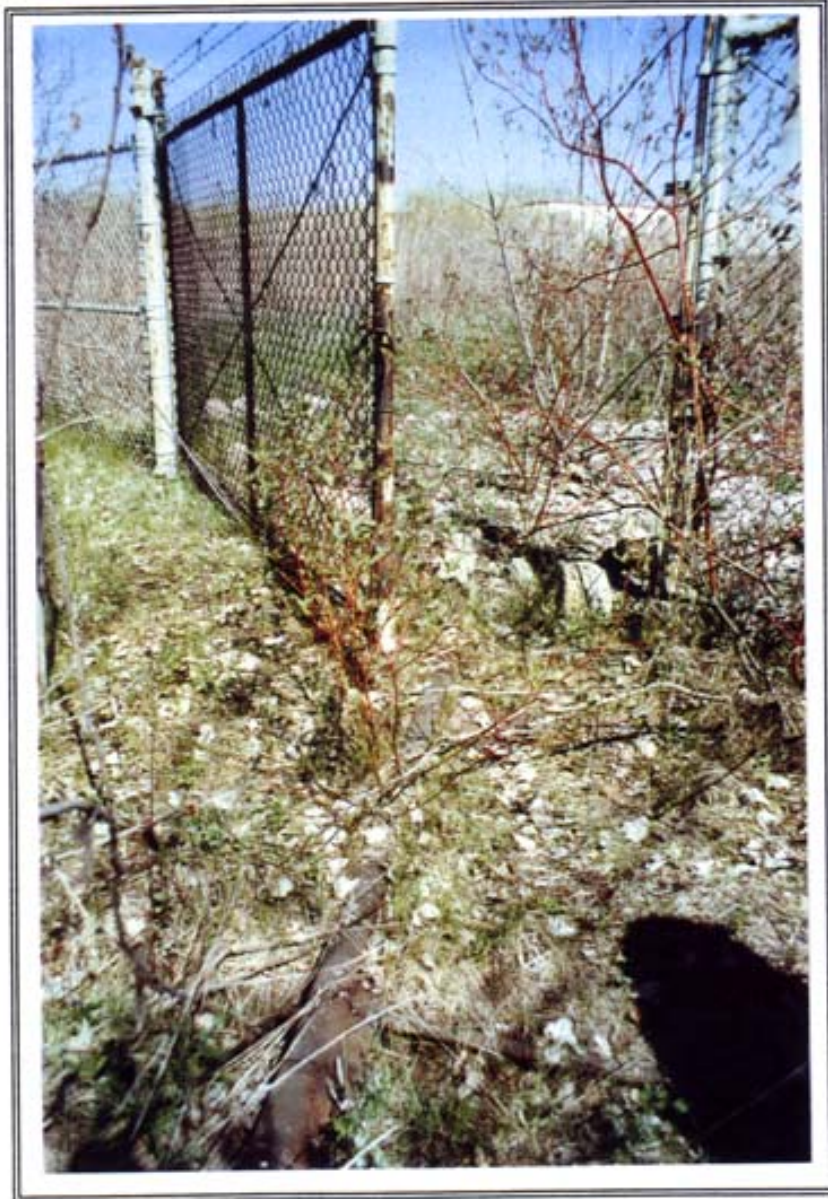
PHOTO 14. 344 VULCAN STREET: View of Former Railroad Spur Route, Facing Northwest.

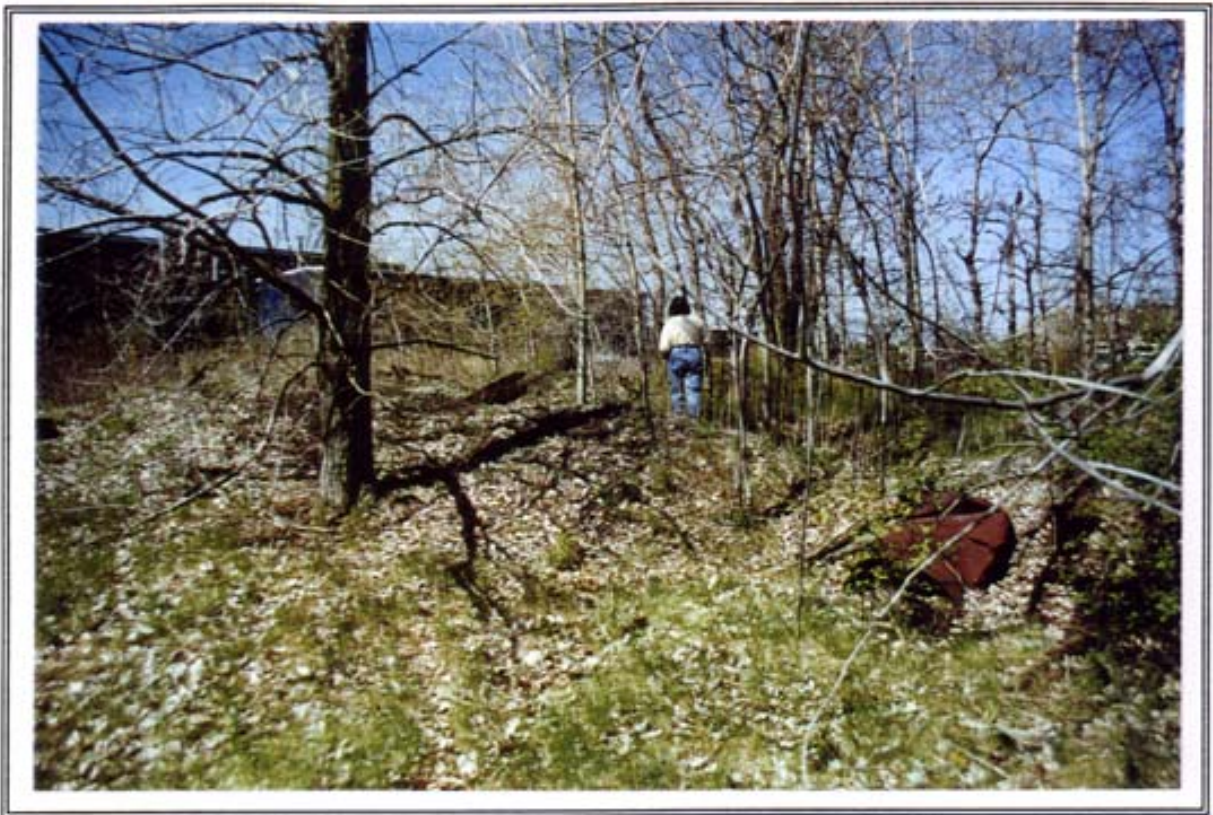
PHOTO 15. 344 VULCAN STREET: Highly Disturbed location Near Former Railroad Spur Showing Mounded Soils, Barrels and Debris From Post-Fire Remediation at Farrel Birmingham Building, Facing Northeast.

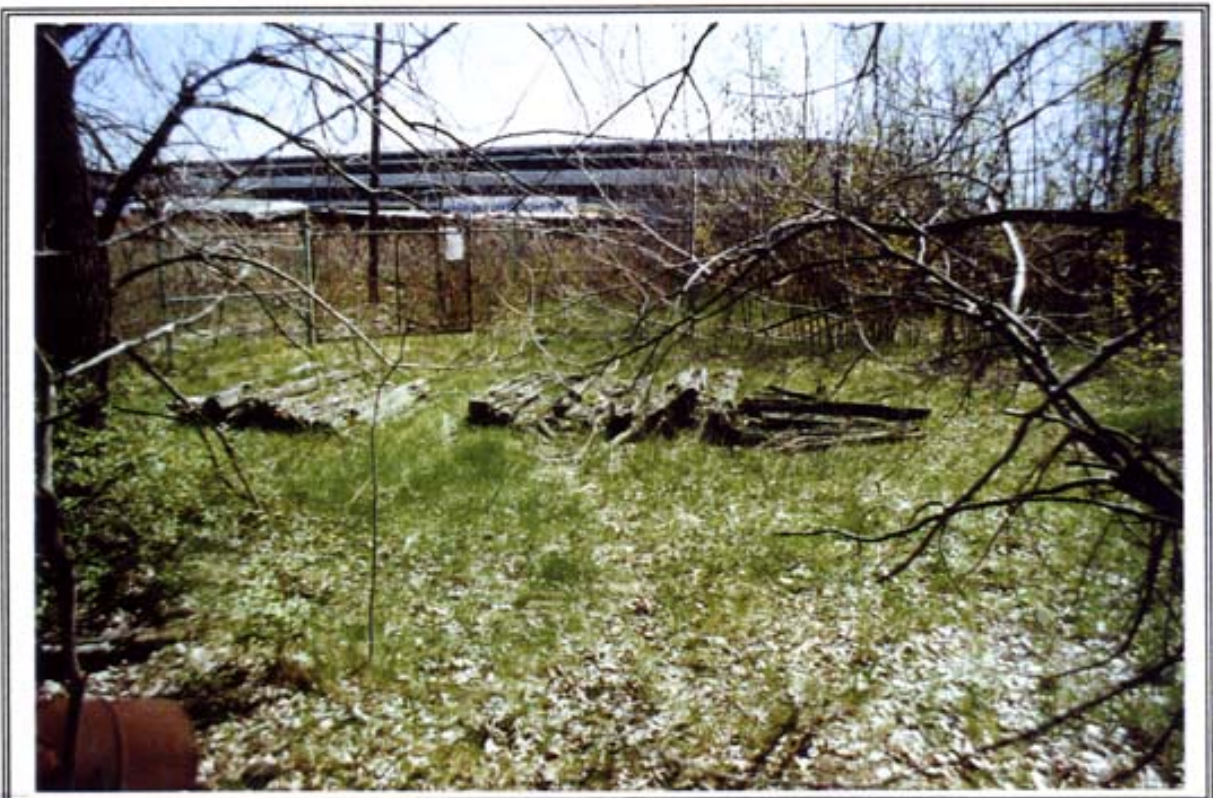
PHOTO 16. 344 VULCAN STREET: Highly Disturbed Location North of Former Farrel Birmingham Building Showing Railroad Ties and Disturbed Soils, Facing North. Northeast.

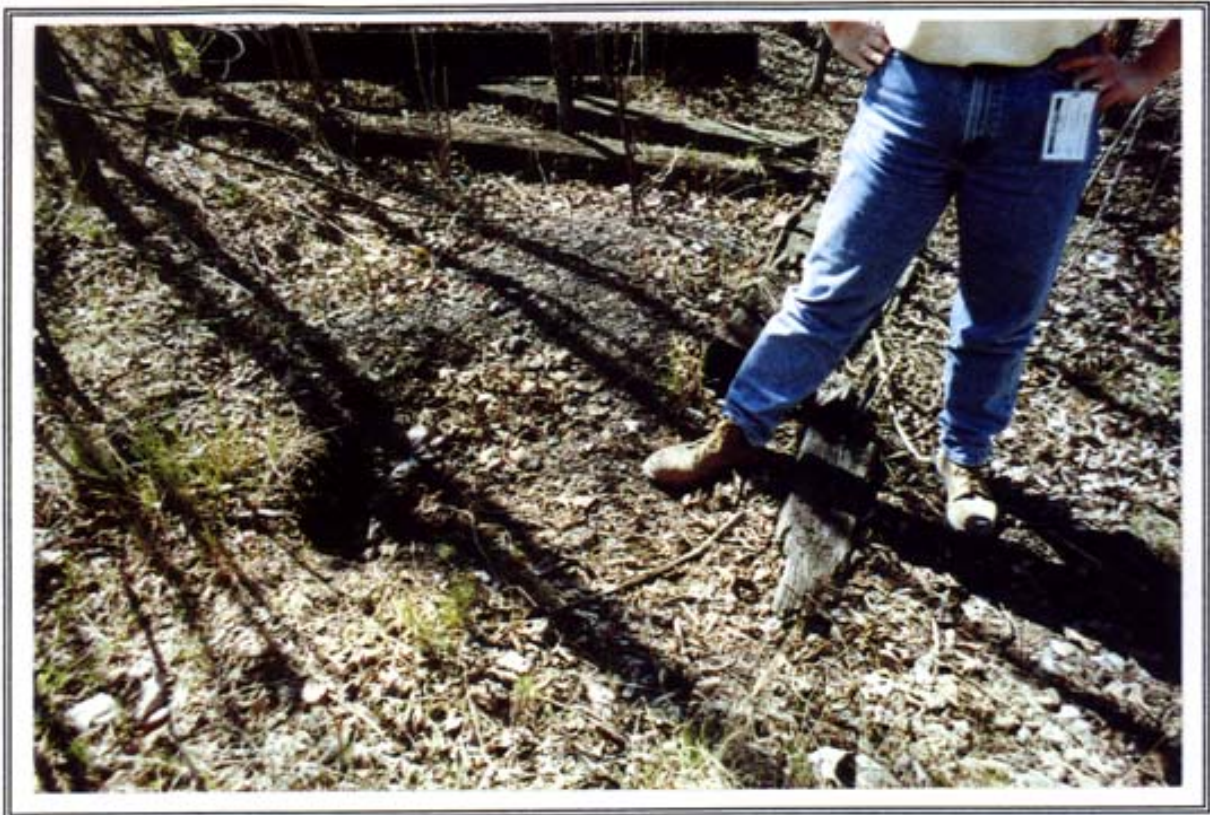
PHOTO 17. 344 VULCAN STREET: View of Backdirt From Animal Burrow Showing High Degree of Fill.

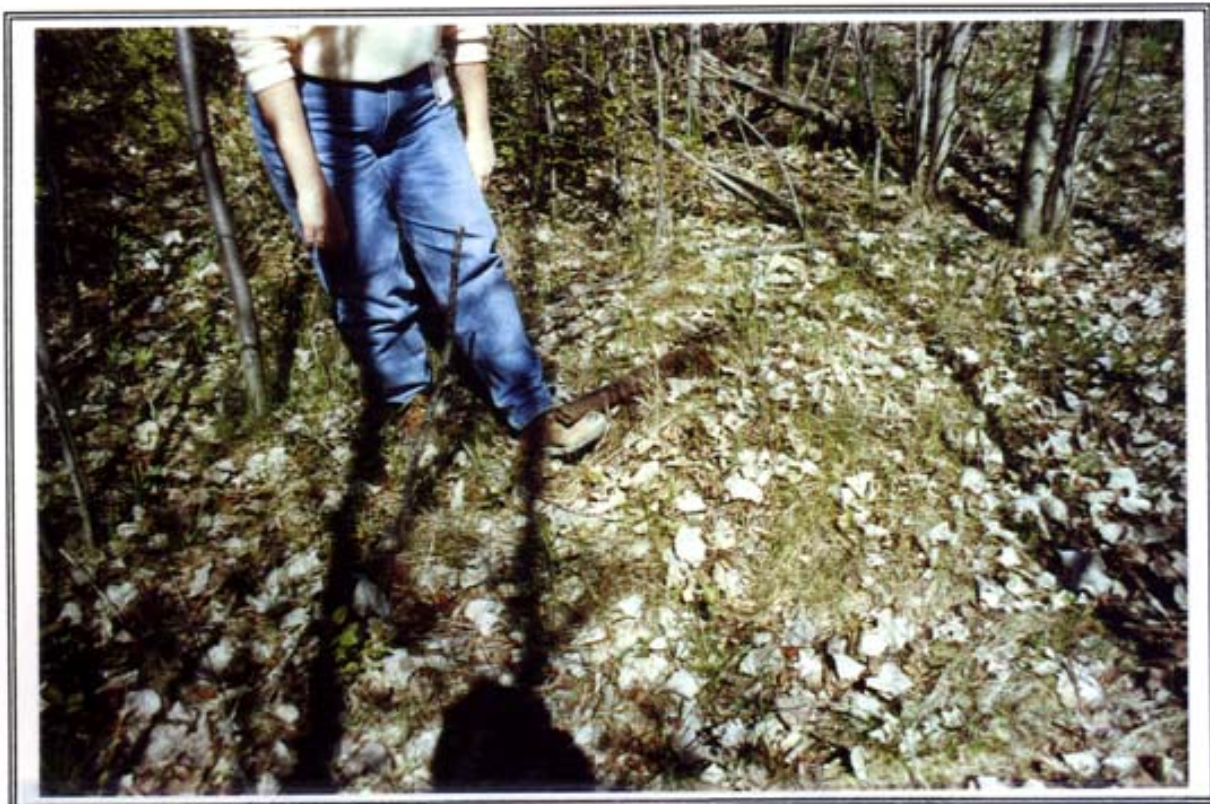
PHOTO 18. 344 VULCAN STREET: View of Highly Disturbed Location Showing Protruding Metal Bars.

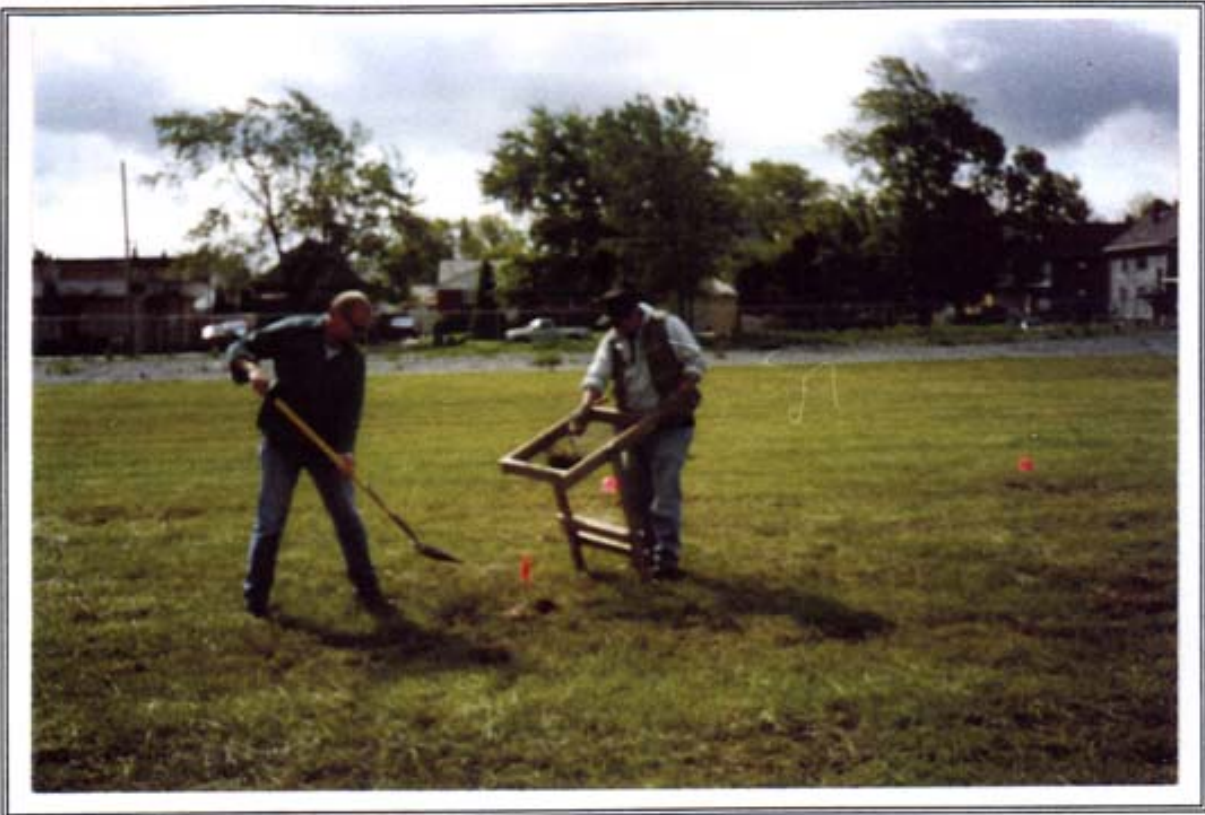
PHOTO 19. 240 VULCAN STREET: Study Area A Showing Close-Interval Shovel Testing Around Positive Shovel Test, Facing South.

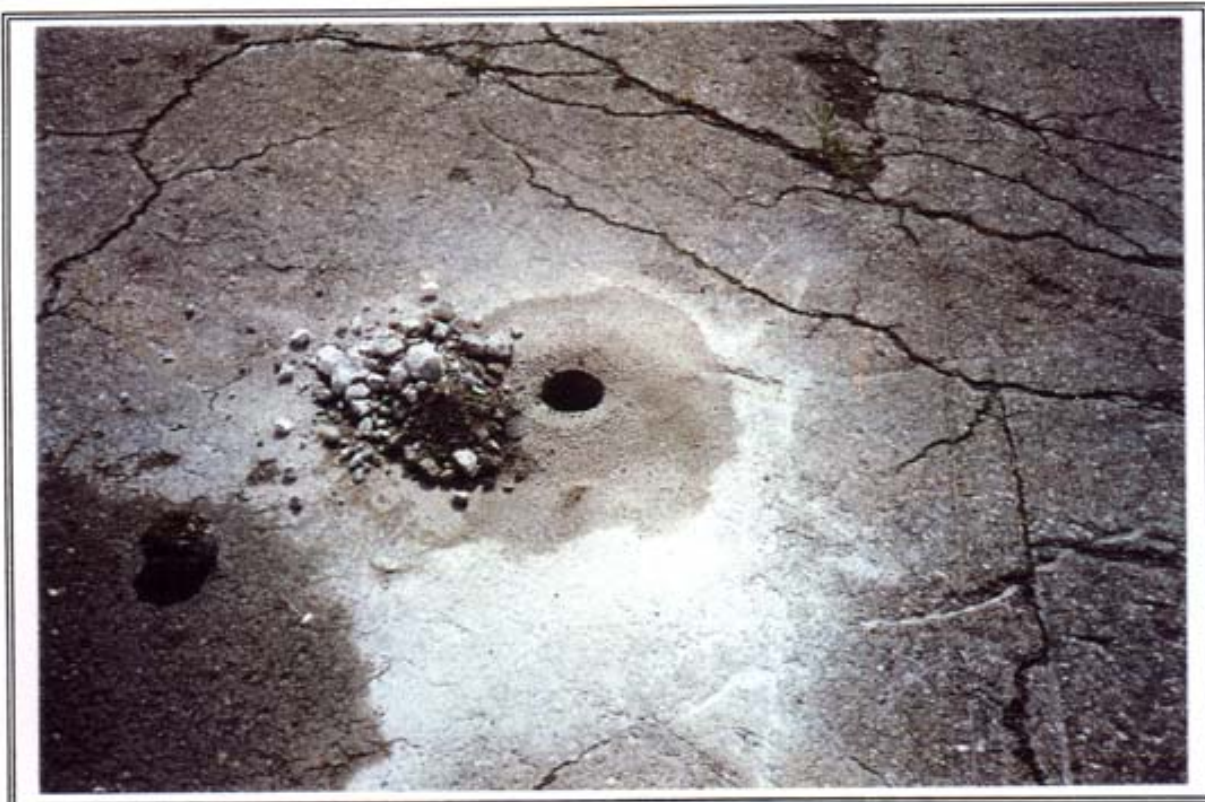
PHOTO 20. 240 VULCAN STREET: Study Area C - View of Core Boring Through Concrete Slab (Core C-3).

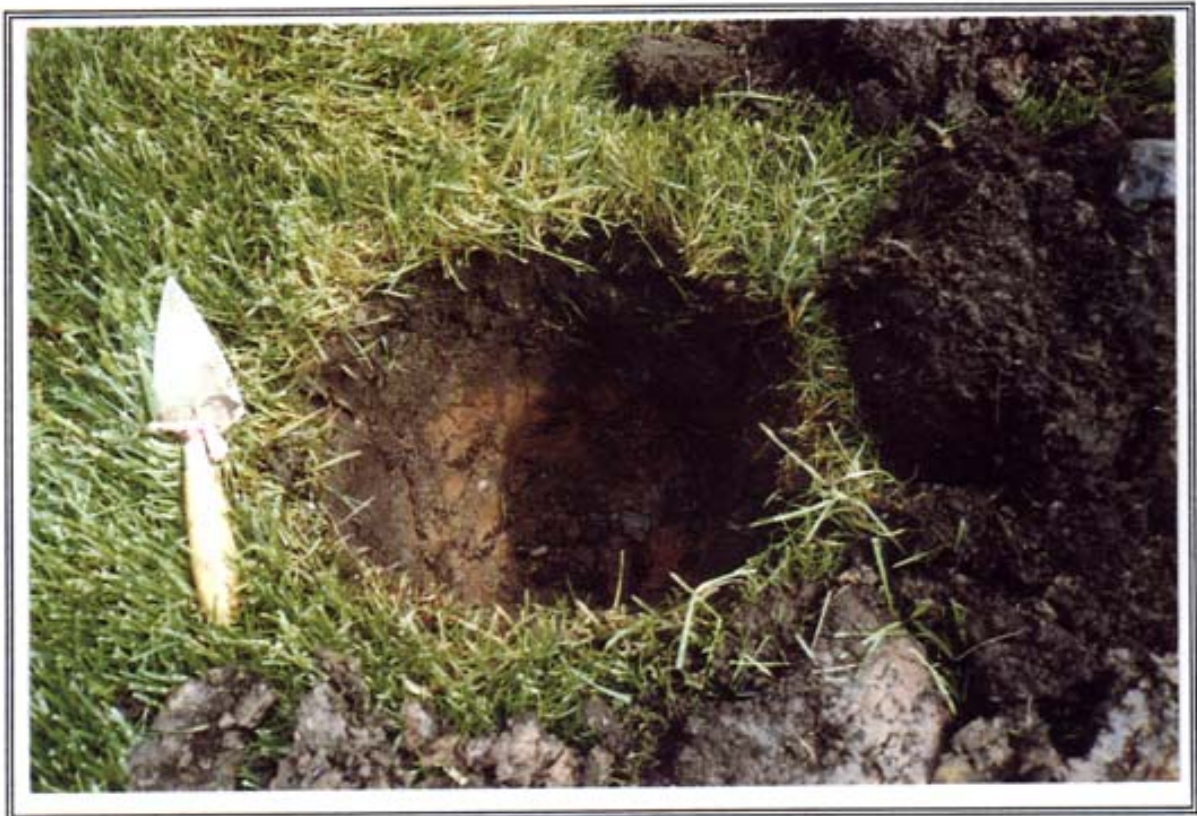
PHOTO 21. 240 VULCAN STREET: Area A - View of Shovel Test Stratigraphy Showing High Degree of Filling and Native Clay Soils.
